# Characterization of historic bricks and binder at Vat Phou World Heritage Site in Lao PDR and selection of compatible replacement units for restoration

Department of Civil Engineering, Indian Institute of Technology Madras, Chennai 600 036, India

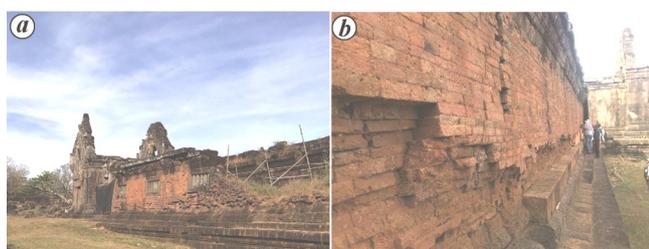
**Figure 2 a, b.** Images showing the extent of damage due to differential settlement at the brick gallery in the southern quadrangle.

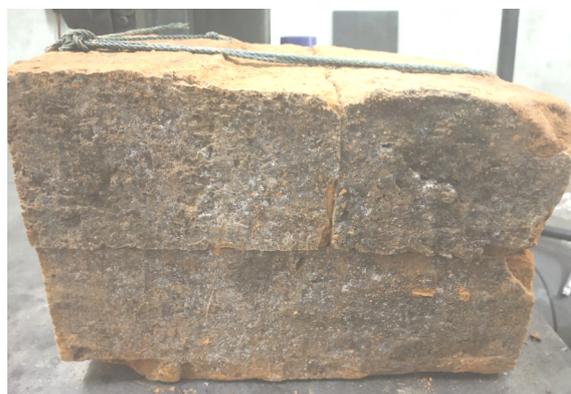
*Visual observations:* The external surfaces of the heritage brick units collected from the site were uneven,

partly eroded and non-uniformly black in colour due to the presence of atmospheric and biological depositions (Figure 3). The internal (unexposed to the external environment) surfaces were reddish-orange in colour. From the cut cross-section, it was observed that the internal core of each of the bricks had a deep black colour, which

**Figure 3.** Historic bricks masonry prism with two bricks bonded together.

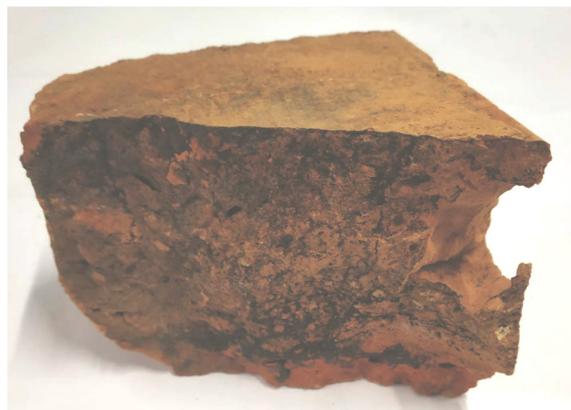
**Figure 4.** View of the cross-section of a historic brick showing the presence of soot.

represents soot (Figure 4). The soot was observed as a deep black powdery layer, generally of amorphous carbon. This suggested the incomplete burning of organic matter. Impressions of rice husk were seen on the surface of the bricks, from the masonry at the site (Figure 5). Fibrous inclusions were also observed in the core of the brick matrix similar to the masonry surface, more obvious in the reddish-orange areas – possibly rice husk, whose presence was then analysed through SEM imaging. Addition of raw rice husk or grounded rice husk ash into the clay during brick manufacturing was practised in ancient times, particularly in the rice cultivation areas, such as the Mekong delta region; rice husk stabilizes the clay and improves shrinkage properties.

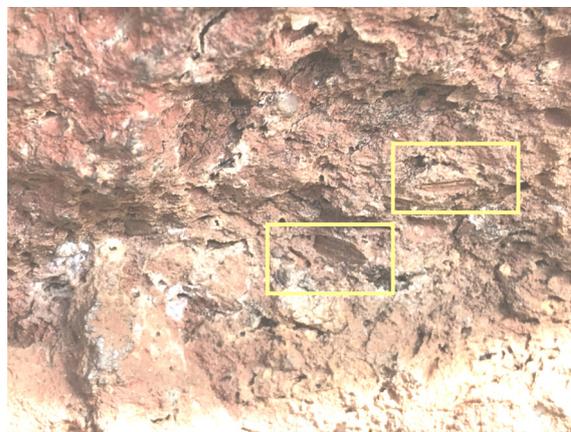
**Figure 5.** Surface of the brick unit showing the presence of inclusions, possibly rice husk.

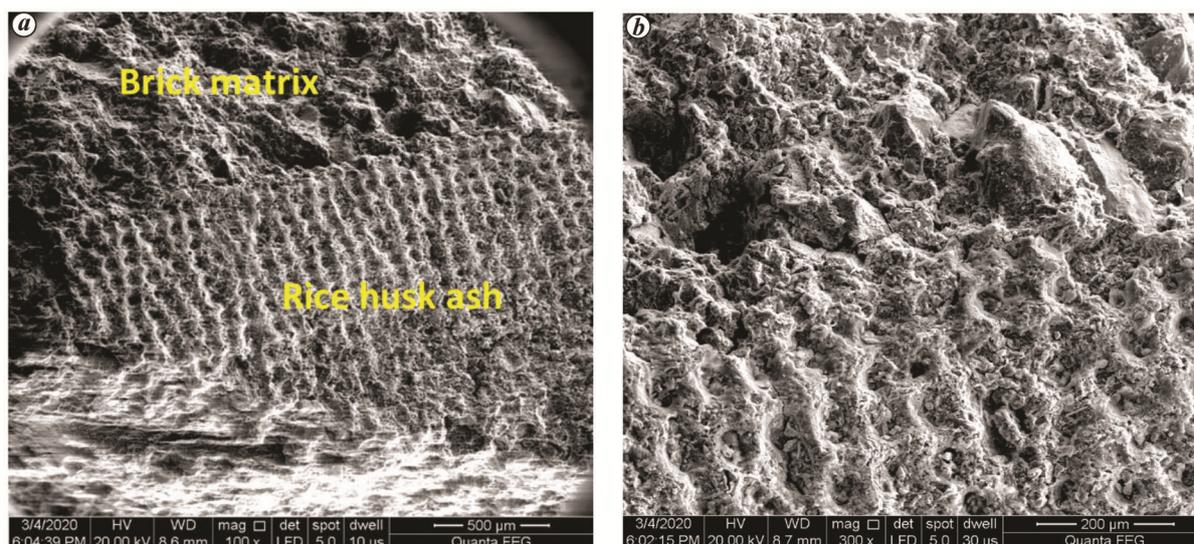
**Figure 6.** *a*, Scanning electron microscope image of the core of a historic brick sample. *b*, Magnified view of the image in Figure 6 *a* showing vesicular morphology of rice husk ash.

sample. Figure 6 *a* and *b* shows the SEM image of the brick sample taken from the core. Rice husk was detected in the brick matrix; it was composed of quartz and feldspar in abundance. The highly siliceous rice husk ash was identified with its highly porous and vesicular morphology, which results in a very high external surface area. Figure 6 *b* shows magnified images of rice husk. In all probability, it was raw rice husk and not rice husk ash, that was added to the plastic clay during the brick manufacturing process to improve the shrinkage properties. Rice husk impressions seen in the reddish-orange portions of the brick support this conjecture, as seen in Figure 3. They also contribute to non-uniform burning during the firing process that was seen as soot in the core. On the other hand, rice husk ash is much finer and has pozzolanic properties, resulting in a lesser negative impact on strength than raw rice husk.

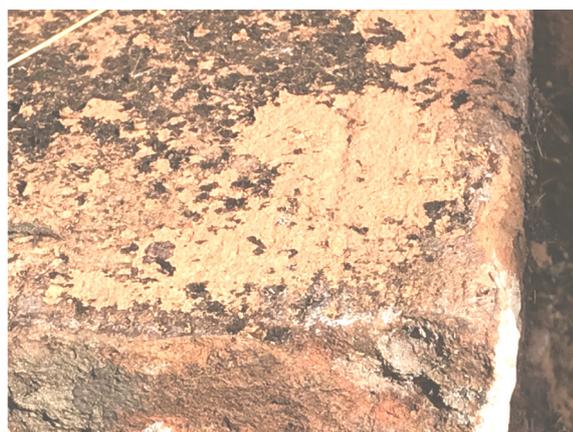
**Figure 7.** Bonded surface of a brick showing the presence of an interfacial layer between bricks.

**Visual observations:** Figure 7 provides visual evidence of the existence of possibly an interfacial layer between the bricks from the site. Reports from the conservation studies conducted at other sites in the vicinity have revealed different inferences. Studies conducted on the brick masonry from temples at the archaeological site of Mỹ Sơn, Vietnam, showed the presence of very thin layers of natural resin that made the bond tight, so that there were practically no real joints between the bricks<sup>12</sup>.

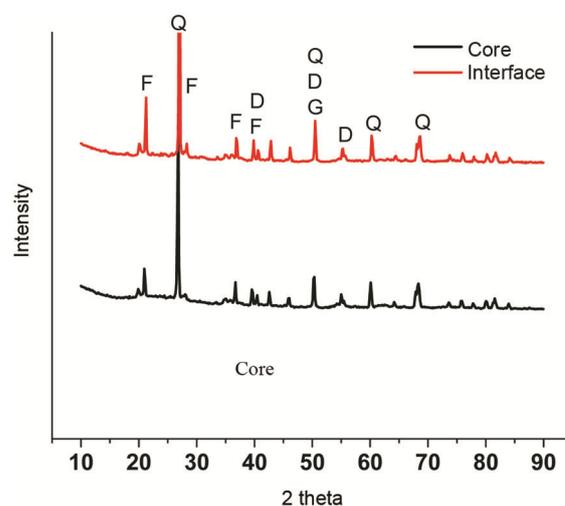
**Mineralogical identification:** Samples were collected from the core of the historic brick and the interface where both the bricks were joined. XRD helps identify any possible differences between the interior (core) of the bricks and the interface between two bricks, which can possibly provide evidence on the binder used. Figure 8 compares diffractograms for the samples collected from the core of the bricks (bottom graph) and the interface (top graph). The major minerals found in both the samples were quartz, feldspar, diopside and gehlenite.

We also examined the presence of lime in the system, if any. This was done because of the standard conservation practice in recent times at historic sites to use lime as a binder during repairs. Confirmation on the presence or absence of lime can influence the choice of new materials during the restoration works. Even though the first peak of lime (at  $2\theta = 37.62^\circ$ ) matched with a peak in the measured profile of the brick system in both cases, the absence of other relevant peaks eliminated the chance of lime being in the system. This clearly indicates that lime was not used as a binder in the system. Also, the similar nature of mineral composition identified between the core and the joining interface suggests that the binder used can be either organic without any crystalline phases, or no binders were used at all. Further analysis at the interface with SEM was necessary to confirm this.

**Figure 8.** Diffractograms for the samples collected from historic bricks. Q, Quartz; F, Feldspar; D, Diopside; G, Gehlenite.

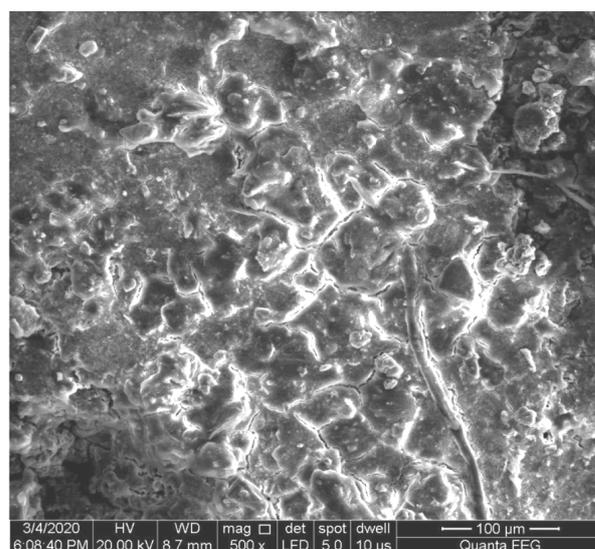
**Morphological features at the joining interface in the historic bricks:** Figure 9 shows the SEM image taken for a sample collected from the interface. The joined surface of the brick was examined by capturing secondary electron images. Clear evidence for the presence of a coating/layer could be seen on the surface in the SEM image, which was not possible with the naked eye. This film suggests the presence of a very thin layer of binder, probably non-crystalline in nature, in corroboration with the XRD results. The bright lines in Figure 10 show cracks within the film, where electron deposition would have occurred due to the discontinuity, which resulted in enhanced brightness in such locations in the SEM images.

**Figure 9.** SEM image showing the presence of a binder layer at the interface between two bricks.

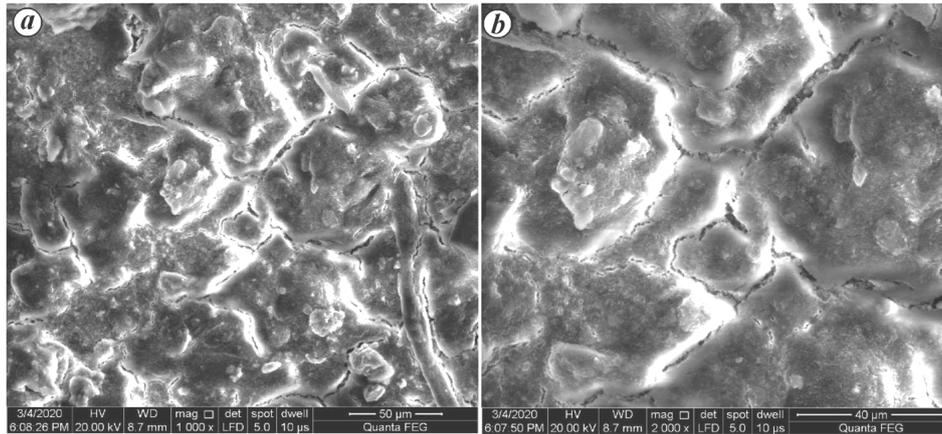
Figure 10 *a, b*. Magnified views of the cracked layer of the binder at the interface. (*a*) At 1000X and (*b*) At 2000X.

The nature of the binder used was studied with the help of mineral identification (by XRD) at the joint of the bricks and SEM imaging on samples collected from the interface. XRD and SEM studies on the joint interface between two historic bricks suggested that no lime-based binders were used in the construction. SEM imaging also confirmed the presence of a thin film of binder/coating at the joining interface between the two bricks. As no specific crystalline materials were identified at this location (interface) through XRD, it indicates the use of a plant extract as natural resin. The applied binder interface had cracks on observing through SEM imaging that represent weathering effects.

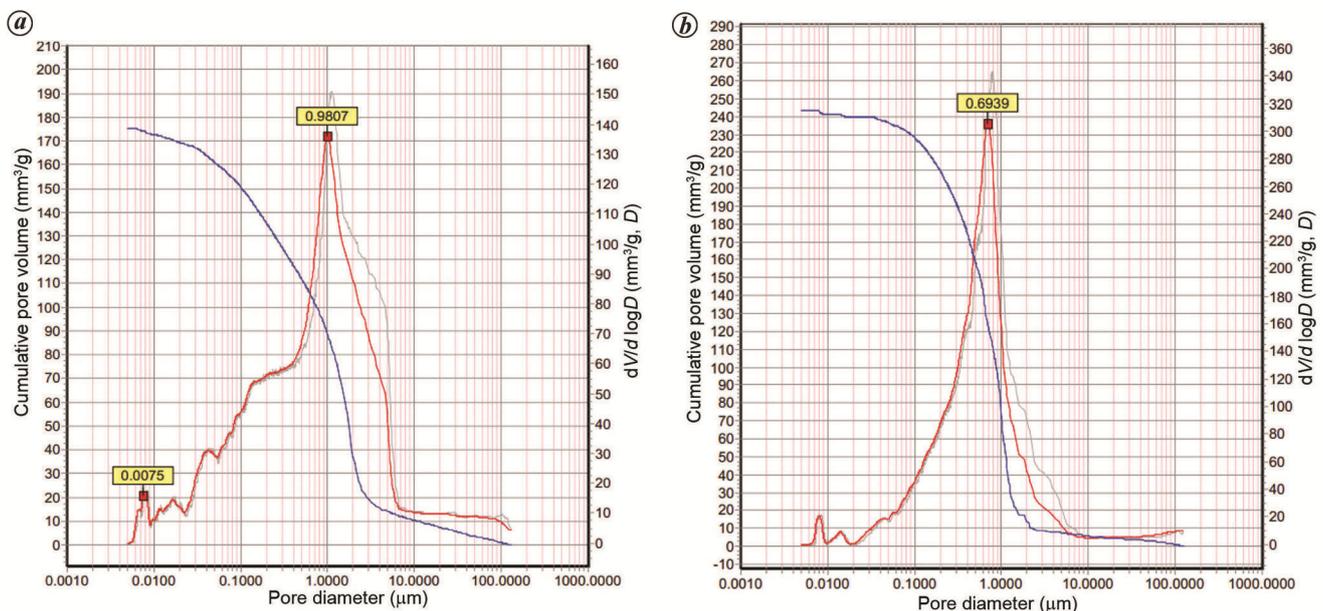
Figure 11. *a*, Intrusion curves for the existing (historic) brick sample. *b*, Intrusion curves for the new brick sample.

ables from the experiment. Critical pore size is the pore diameter that corresponds to the highest frequency of pore size, and is obtained as the peak in the differential intrusion curve; threshold pore size is the minimum continuous pore diameter, after which a sudden influx of mercury can be seen in the cumulative intrusion curve. Systems that have finer pore size are expected to have lower values for both these parameters. Figure 11 *a* shows the intrusion curves for the historic brick sample and Figure 11 *b* shows the same for the new sample. The blue curve shows the cumulative volume intrusion and the red curve shows the differential intrusion in the figures. The peaks of the differential intrusion curves are also marked, which are the critical pore sizes. In the case of the historic sample, the critical pore size (which indicates the most common pore size in the system) was

0.98  $\mu\text{m}$ , while that for the new sample was 0.69  $\mu\text{m}$ . Both values are less than 1  $\mu\text{m}$ , which will thus result in similar durability properties<sup>14</sup>. There was a small increase in the threshold pore diameter of the historic sample compared to the new sample. This was also observed in the case of the critical pore size. However, the difference can possibly be due to the existing level of deterioration because of weathering in the historic samples.
