Eruption of Molten Rock Material from Vikarabad Area, A.P. – D.V. Reddy, R. Rangarajan, Simanchal Padhy, G.B.K Shankar, G. Rajender Reddy, NGRI, Hyderabad; Email: ngi.dvr@gmail.com

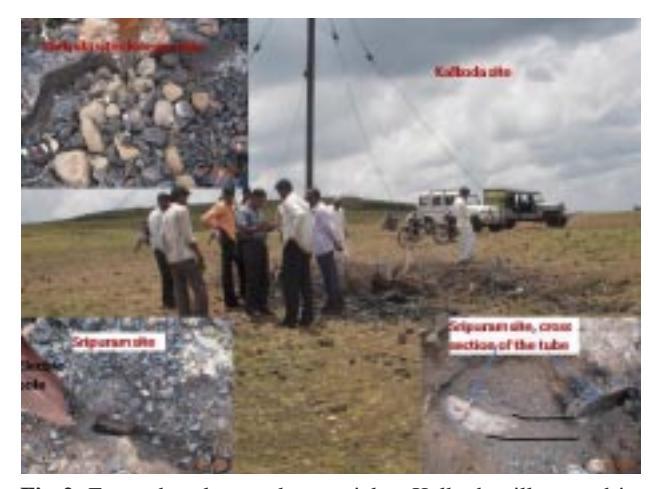
spot (here after called as P1) has heavy eruption (Fig. 2), created a huge cavity up to a depth of 1 - 1.5 m below ground level (Fig.2 top inset). Visual observations indicates that the erupted low density, shining and porous granular material spread over few square meters in the form of thick black/grey black coloured slag and glass. At another spot (P2), the molten rock material appears to have gushed out with a great pressure from a 2-3 cm diameter hole. Incidentally, these two eruptions have occurred at the steel electrical poles (11 KVA line). At P1, the electrical pole is

Fig 2. Erupted molten rock material at Kalkoda village and its close-up view. Two insets at bottom is Sripuram site and (~50 cm deep) was the excavated portion.

supported by the stay wires in all four directions. The cavity formed at this site spread in between the electrical pole and the stay wire in the eastern side.

Another eruption site is at Siripuram village, about 15 km ENE of the Kalkoda site. The erupted material has spread over <1 m² area and the eruption was from a hole adjacent to the electrical pole (11 KVA, Fig.2 bottom left inset). Here also the molten rock material appears to have gushed out with a great force and spread around. Though the incident was reported on 15th August, this might have happened earlier than 15th and nobody might have noticed it.

A small trench made across the hole from where the molten material ejected at Siripuram site. In this trench a tube like structure with a diameter of 8 to 25 cm and about 70 cm long is found. However, the second end of the tube was closed. Highly polished inner wall of the tube looks like polished metallic surface (Fig.2, bottom right inset). The tube wall thickness varies from 3-4 cm where the burning intensity reduced from inside to out side till the original soil contact. The tube like structure indicates the core from where the molten material gushed out with a great pressure and due to that the polished surface is formed. Slag and glassy material formed due to burning of soil, gasses escaped from the soil pores and also soil moisture breaks in to vapors due to severe heat generated by electric current.

Such glassy material called fulgurite is reported earlier by Jayakumaran (Curr. Sci. v.75(8), 1998, pp.763-764) to have formed due to lightning at Udiyur in Periyar district of Tamil Nadu. The texture and shape of fulgurite is typical of superheating, instantaneous melting, and rapid cooling. In the present case, the material observed in the area is similar to fulgurite but it is not formed due to lightening. As there was no major rainfall event in the month of July and August. In the present case, the phenomenon is due to the intensive heat developed due to current leakage from the electrical pole. At P1, a part of the steel pole had the corrosion spots, indicating the evidence of heating below the ground level. Hence we ascribe this event to shortcircuiting of high voltage (11 KVA) power line. The discussion we had with electricity board people shows that the faulty insulator at the top of the metallic pole is the reason for the leakage of current. The methodology used in in-situ vitrification of soil (US Patent 4376598; http://www.patentstorm.us/ patents /4376598/description.html) also confirms the hypothesis proposed by us. It shows that fugurite can be formed due to electrical short circuit.
