On-site visualization monitoring for long span bridge on Delhi Metro Project

A new monitoring scheme, based on the concept of on-site visualization (OSV), was successfully applied for monitoring safety conditions during construction of a long span cantilever bridge in Delhi Metro Phase-II project in 2010. The bridge construction with challenging features included a 100 m long span over the Northern Railways tracks passing below, the balanced cantilever construction methodology with a see-saw condition of the pin-connected girder during segment casting processes and a horizontal curvature of the girder with 300 m radius. The light-emitting sensors with dual functions, namely sensing and simultaneous visual output of measured results, were employed in this project and played crucial roles to capture unique behaviours of the bridge under construction and to ensure safety throughout the project.

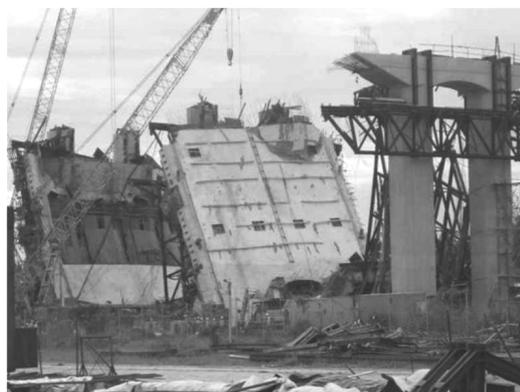
Figure 1. Bridge collapse during construction stage².

Long span bridges, including suspension bridge, cable stayed bridge and box girder bridge become rigid and stable after completion of construction. However, these long bridges could be instable during construction stages (Figure 1)². Any unbalanced loading caused by dead load, live load, structure deformation and ground settlement can lead to catastrophic failure of the total structure. In Vietnam, the requirement of loading test for bridge structure and supporting structures is specified in Industrial Standard³ and its application became more strict after the Can Tho Bridge accident.

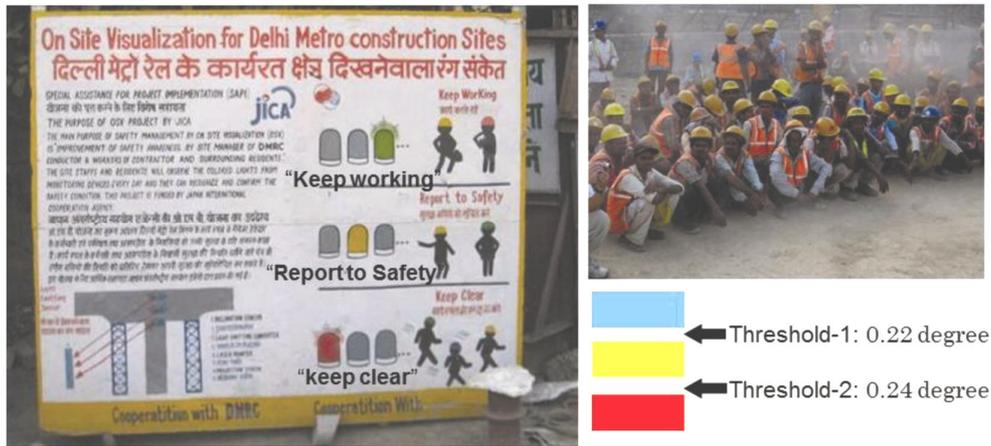
Figure 13. OSV safety board showing safety action plan and site audit at site.

The safety induction talk was conducted inviting all site staff and the OSV safety plan was explained using a notice board as shown in Figure 13.
