## INVESTIGATION ON THE IMPACT OF CLOUDBURST IN TEHRI DISTRICT, UTTARANCHAL – 31 AUGUST 2001

**The catastrophic landslides of Gona village, which took place on 31 August 2001, has been subjected to field investigation. Our study indicates that a combination of several factors are responsible for this tragedy, but the action of water during the cloudburst was the main triggering factor.**

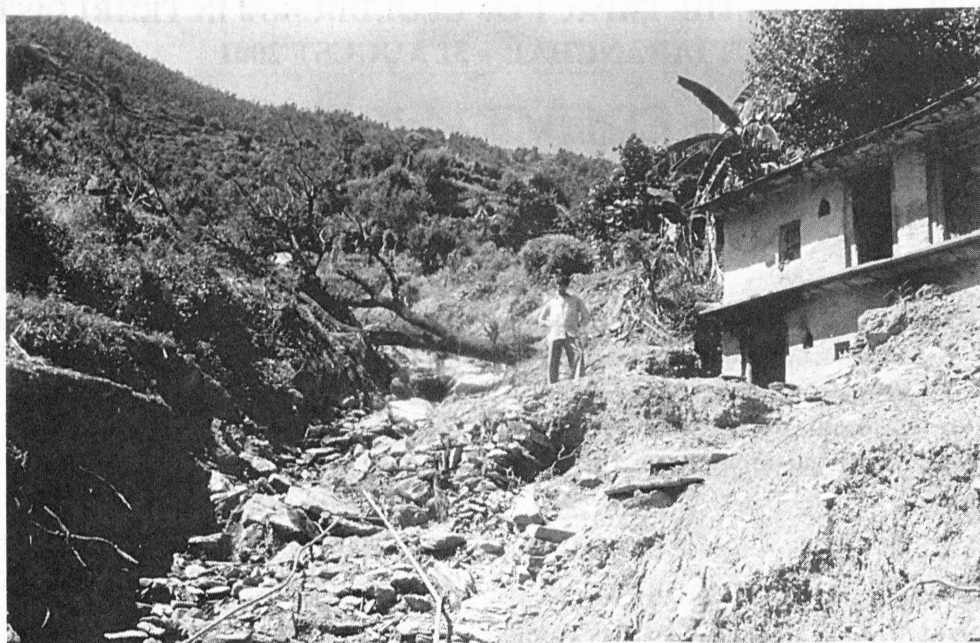
**Fig.1.** Trees and large boulders have dammed the stream in the upslope direction of the village Gona.

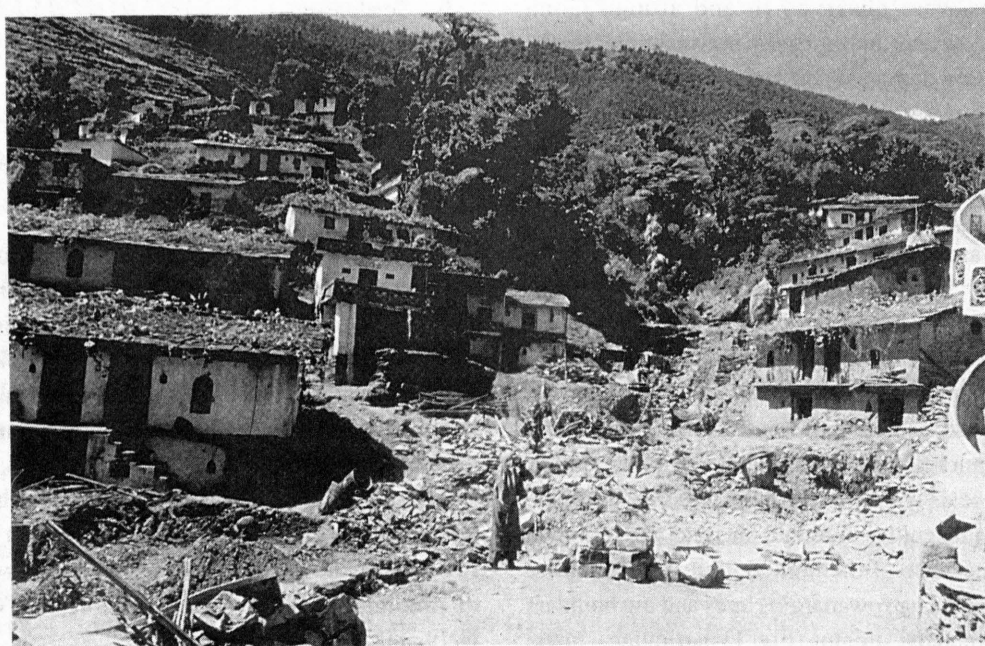
**Fig.2.** On the subsequent breaching of the dammed stream widespread damage was caused all along the stream due to debris flooding.
