# An Integrated Tribological and Vibration Signal Behaviour of TiN and AlCrN based PVD Coatings for Roller Bearings

## Abstract

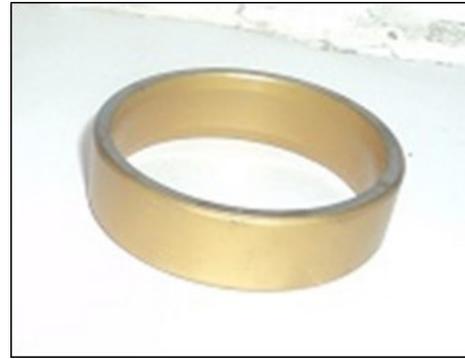
**Figure 1.** Bearing outer race coated with TiN.

The process is carried out between temperatures 150<sup>o</sup> C to 500<sup>o</sup> C and in high vacuum. The evaporation of great purity solid coating materials (chromium, titanium and aluminum) is done by applying heat. A reactive agent like nitrogen with carbon gas is passed at the same instant. This produces a product with the metal vapor and gets placed on the bearing outer race. A thin and greatly adherent coating is produced. The parts are revolved at uniform speed to get uniform thickness of coatings. Figure 1 shows the coated outer race of the bearing.

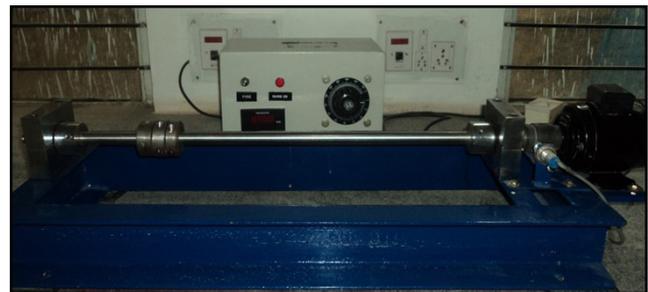
**Figure 2.** Experimental Bearing test rig.

Figure 2 shows the test rig employed in this study. It consists of a shaft supported on two bearings. At one end there is ball bearing of self-aligning type and at the other end there is roller bearing which is to be tested. The roller bearing is tested at constant load of 100 N and at a constant speed 1000rpm.

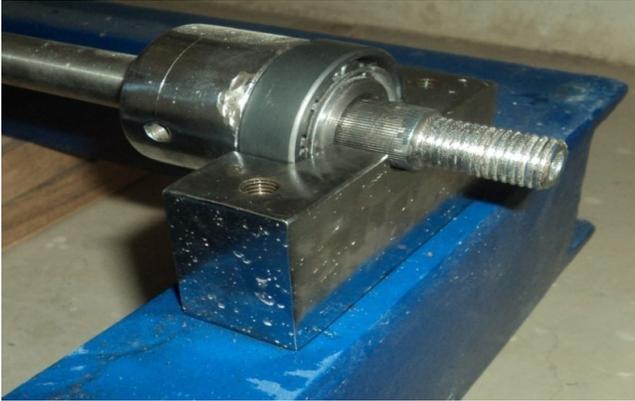
**Figure 3.** Mounting of coated test bearing.

The shaft is turned to the designed diameter on a precision lathe. Two bearing seating on the shaft are ground and hardened. Figure 3 shows the AlCrN coated bearing in its housing. Table 1 shows the Specifications of the test bearing employed in the experiment.
